JUDGE HART

The Hart of Lake Superior

by Matthew M. Turchi and Darryl Ertel

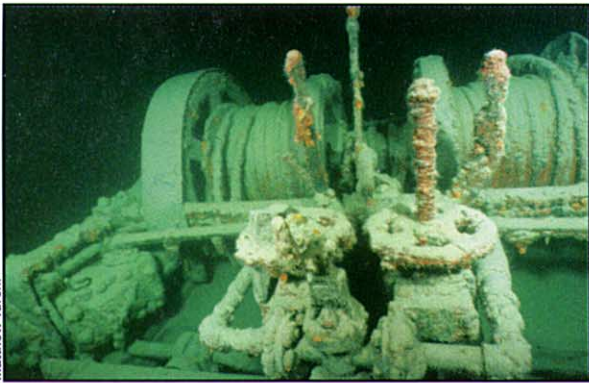
*Left:
Windlass,
located on
the bow deck*

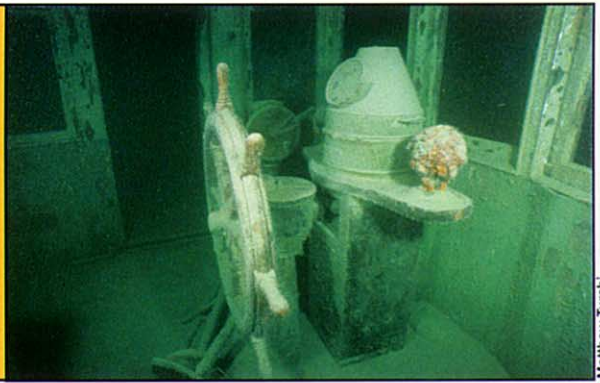
*Right:
View of the
inside of the
Pilot House.*

The pilothouse is the most exciting part of this wreck. It is rare to find an intact wooden pilothouse on a shipwreck because most of them are blown off upon sinking. We believe that the ice may have prevented it from disintegrating when the ship sank. Two of the forward windows are opened which was described by the crew as their only option to see during the storm. Inside, the ship's wheel and binnacle are the most striking features. They are in excellent condition and there is no evidence of damage or significant deterioration. The pilot's stool is broken on the floor but may have been damaged

before the *Hart* sank. The telegraph indicator is in the slow position, just as the captain had ordered. A desk is in the back corner and has a directional rangefinder on it. This was an early LORAN and was used for navigation. Another interesting find were the framed schedules that still hang above the windows. They appear to have Morse Code signals of various ports and were used to navigate. The glass that is covering these schedules is still intact and the words are legible after 55 years! Aft of the wheelhouse on the rear companionway is a second binnacle with an enclosed compass. This binnacle being behind the wheelhouse, is in a rather curious location for a compass. Many steamers have their auxiliary compasses forward of the pilothouse. Just aft of the binnacle is the forward mast with its attached brass bell.

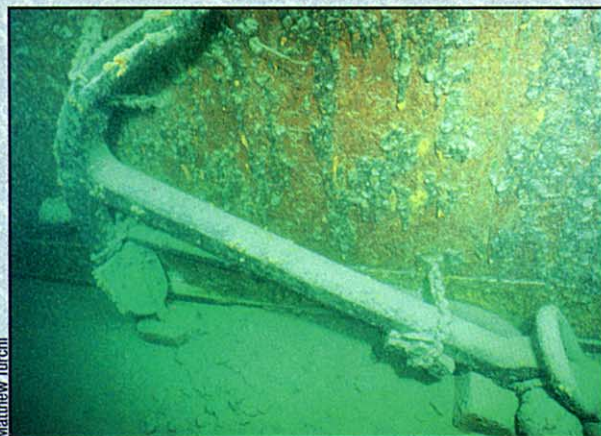
Left:
Ship's extra anchors, located on the forward wall of the stern cabins.

There are two anchors attached to the forward wall of the stern cabins. The starboard one is a more modern-day type and the portside one has a stock and flukes. On the deck forward of this older anchor is a partially crushed metal drum. An oval, brass builders plate is attached to the forward facing wall of this stern cabin. All that can be read is *Coves* where the ship was built in 1923. The top of the stern cabin is somewhat undamaged. The smokestack with its attached whistle and foghorn is bent back along the top of the cabins. Apparently the ice did not save this from damage during the sinking. The rear mast is still standing and the cross trees still have intact running lights with air sealed

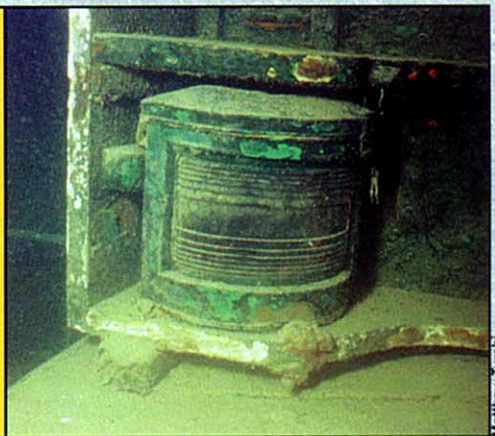
Right:
Running light, located on both the port and starboard upper deck.
